PUTNAM LAKE DAM

INVENTORY NO. N.Y. 90

**PHASE I INSPECTION REPORT
NATIONAL DAM SAFETY PROGRAM**

SEPTEMBER, 1978

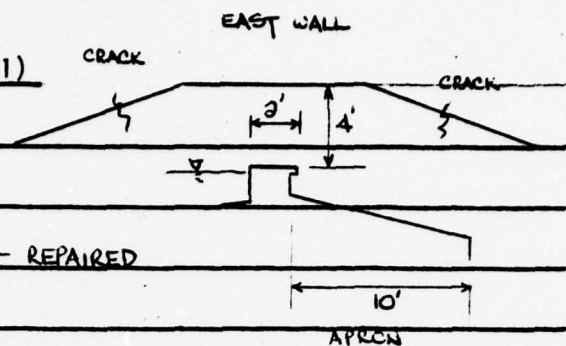
6) Spillway(s): (including tail race channel)

a. General 2 CRACKS IN EAST WALL - REPAIRED

b. Principle Spillway CONCRETE - GOOD CONDITION (INCL. APRON)
